Repeating Defects

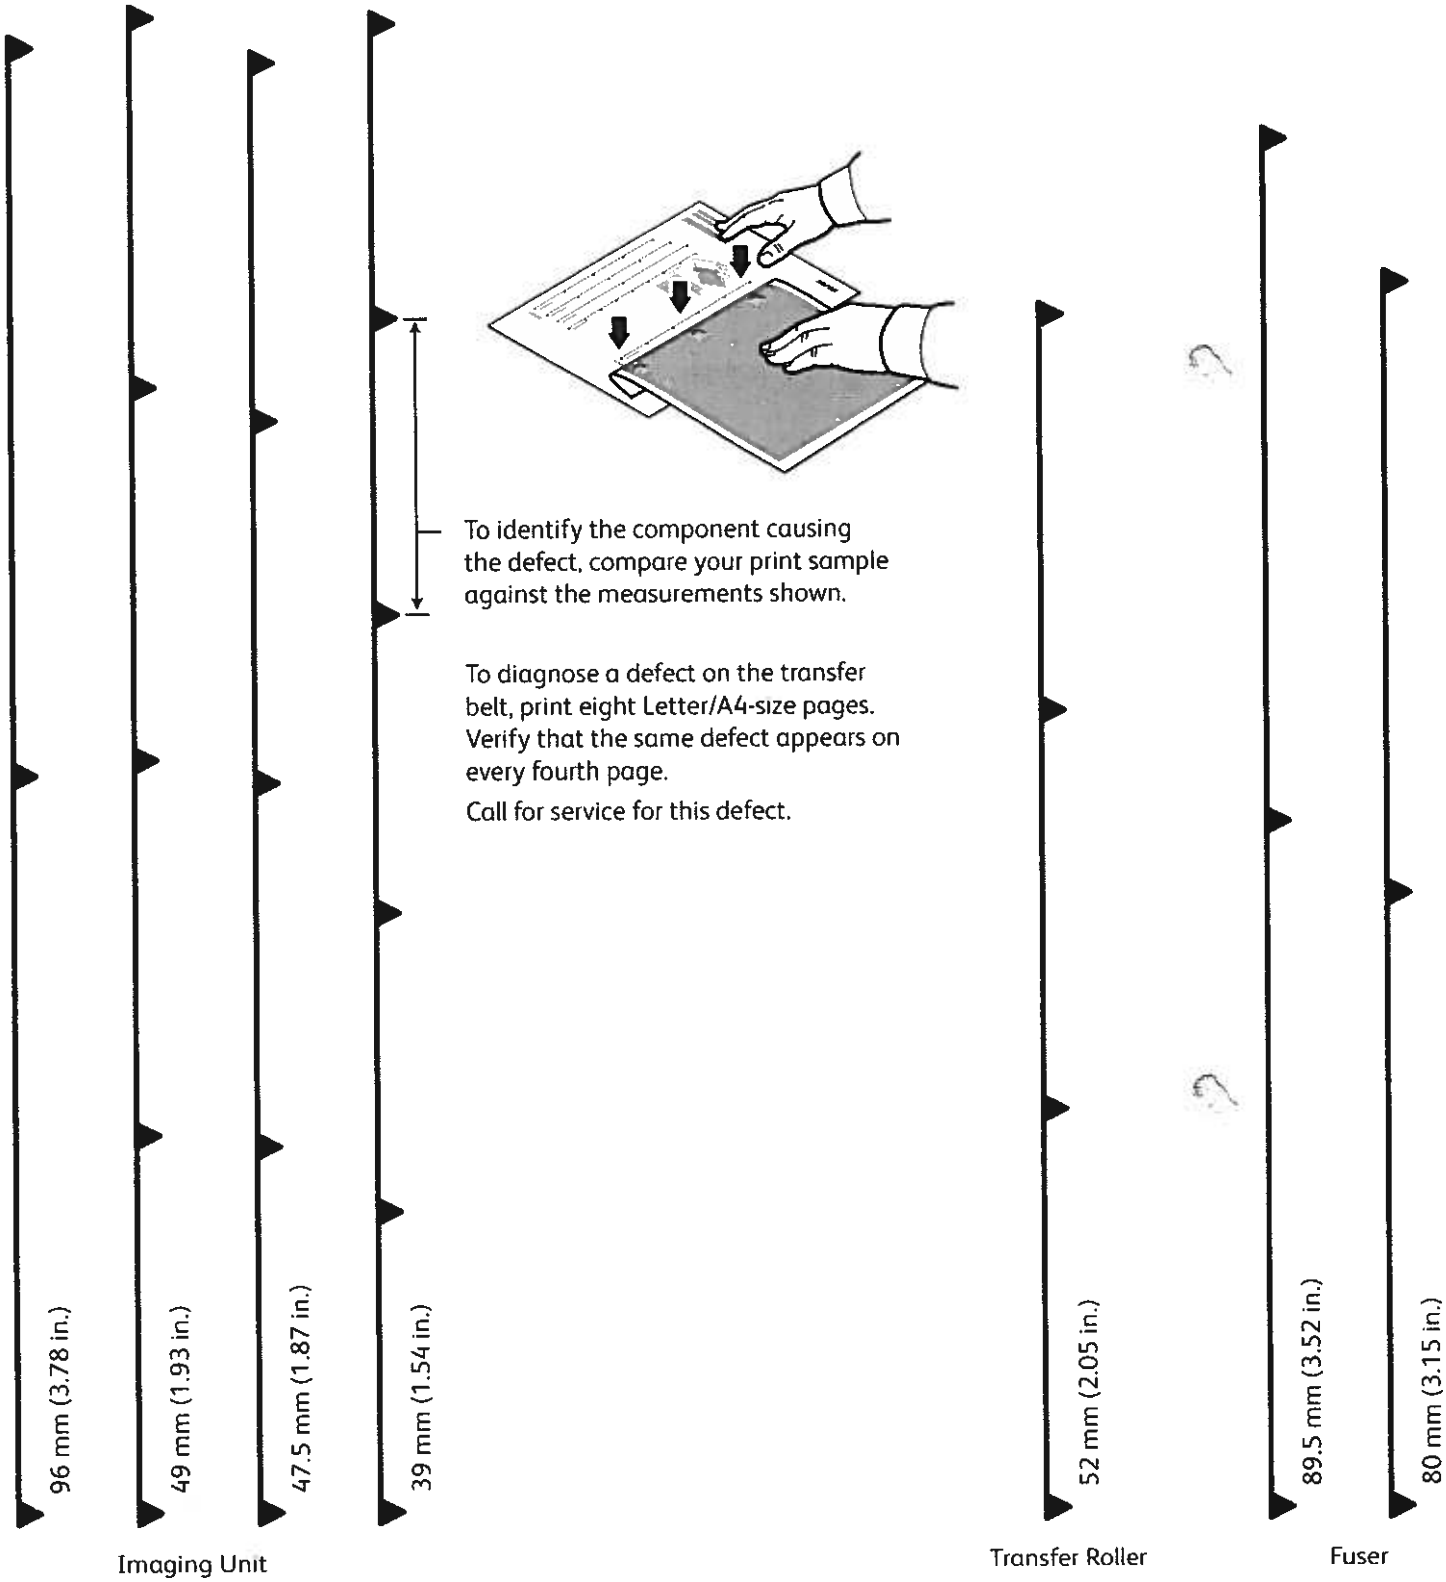
To identify the component causing the defect, compare your print sample against the measurements shown.

To diagnose a defect on the transfer belt, print eight Letter/A4-size pages. Verify that the same defect appears on every fourth page.

Call for service for this defect.
