# Repeating Defects

Xerox® Altalink® C8230/C8235/C8245/C8255/C8270  
Color Multifunction Printer

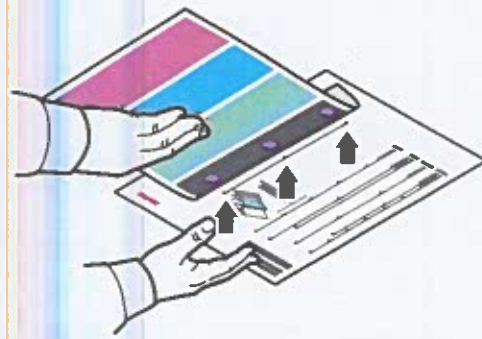
To identify the component causing the defect, compare your print sample against the measurements shown.

Drum Cartridge  
95 mm (3.74 in.)  
38 mm (1.50 in.)

Second Bias Transfer Roll  
65 mm (2.55 in.)

Fuser Pressure Roll (Service only)  
88 mm (3.40 in.)

Fuser Heat Belt (Service only)  
96 mm (3.78 in.)

Developer Roller (Service only)  
33 mm (1.29 in.)
