37598 / 3759L

Repeating Defects

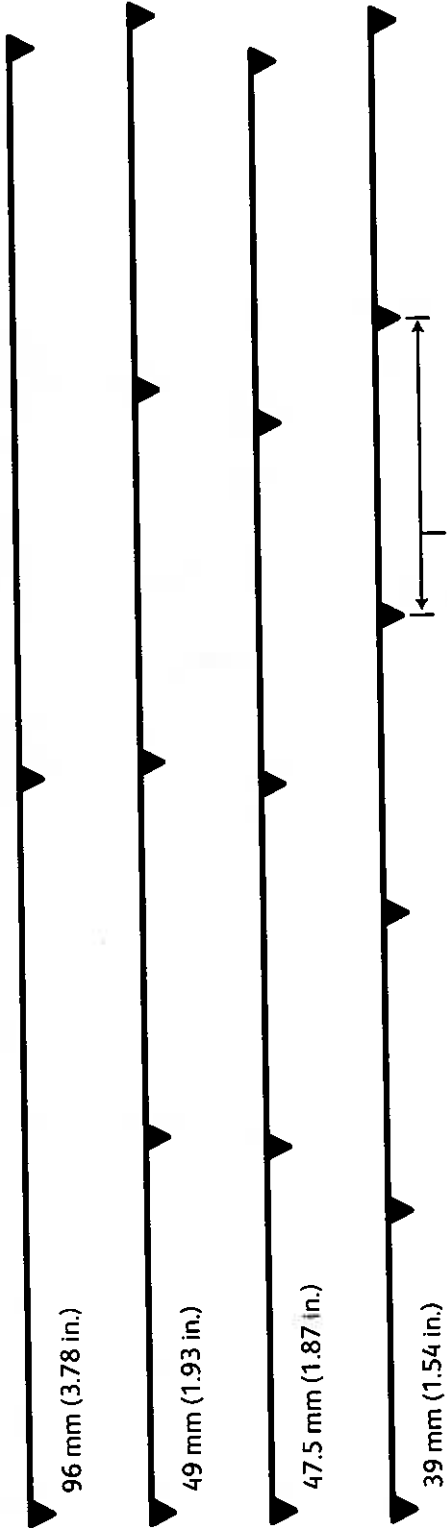
To identify the component causing the defect, compare your print sample against the measurements shown.
